An Investigation of Rock Fall and Pore Water Pressure using LiDAR in Highway 63 Rock Cuts

An Investigation of Rock Fall and Pore Water Pressure Using LIDAR in Highway 63 Rock Cuts

**NUTC
R364**

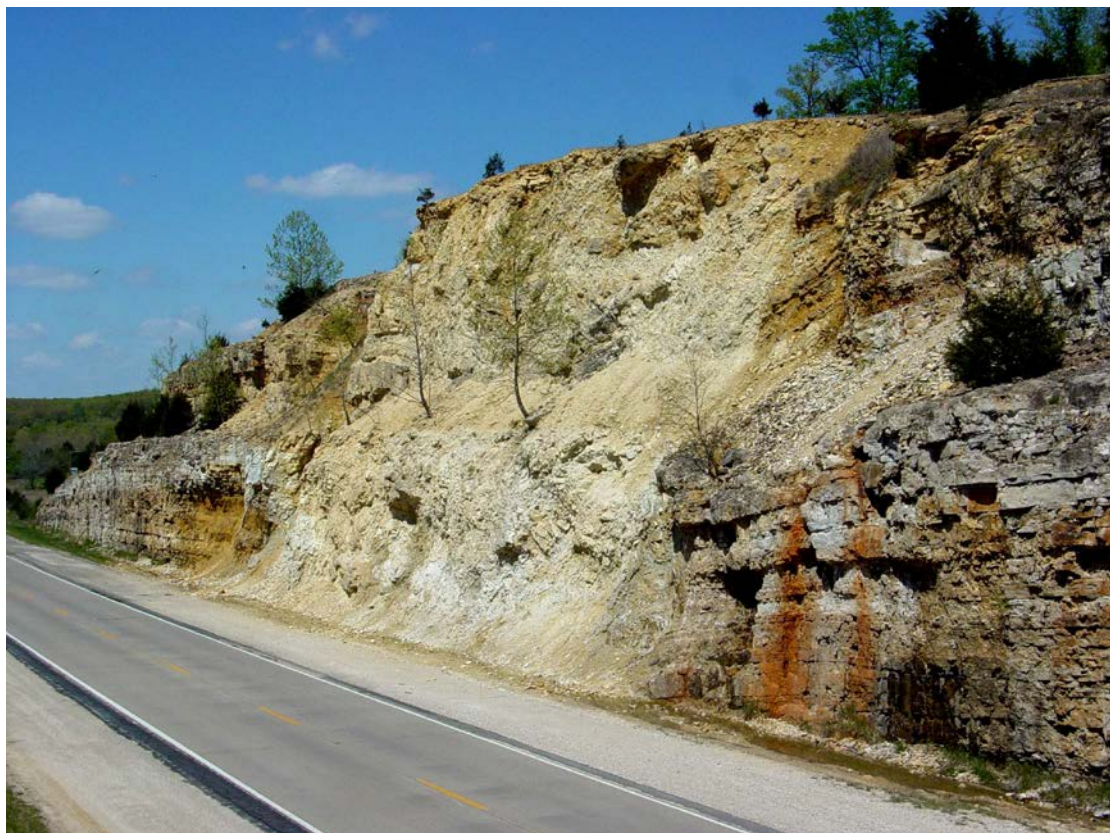
Two rock cuts were selected for this work along Highway 63 just north of Rolla (Figure 1). Site 1 (Figure 2) was located on a problematic rock cut that traverses across a filled sinkhole. This rock cut is constantly raveling and the ditches below this rock cut have been cleared of debris many times. Site 2 (Figure 3) was located just outside of a local operational quarry, where the seismic effects of blasting would contribute to rock fall. This location was chosen because there was evidence of both rock fall and groundwater leakage.

Figure 2: Site 1. This is a filled sinkhole that requires ongoing maintenance.

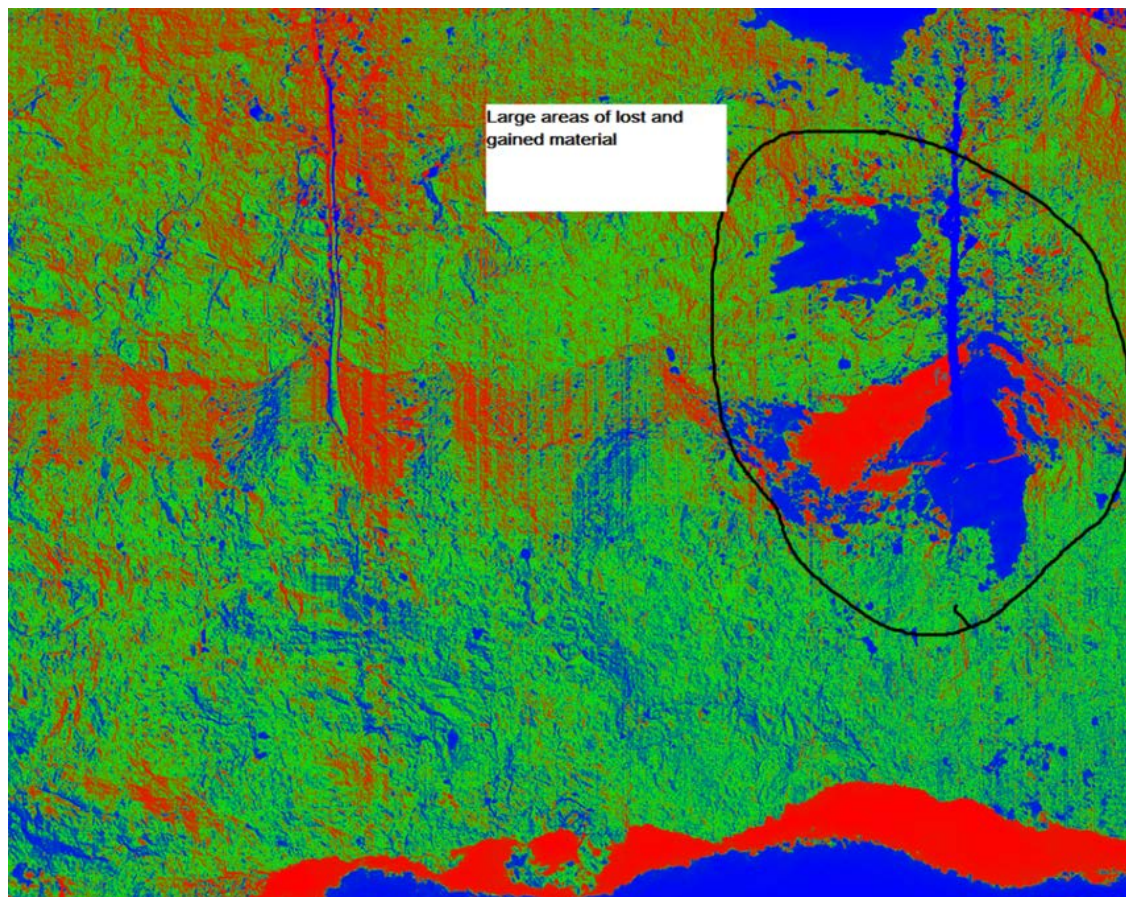
Figure 15 shows the raw results of the change detection algorithm, which nominally shows lost material in blue, gained material in red, and no change in green. The algorithm also has a vegetation removal aspect, however in Figure 15, the tree of Figure 14 (right hand true) is physically missing because it has either fallen down or been removed by the Missouri Department of Transportation personnel.

Figure 15: Initial results of change detection algorithm. Gained material is shown in red, and lost material is shown in blue. Note that tree in Figure 14 has been removed. The bottom of the image shows fallen rock.
